# Kyanite Mining Corporation

## 2022 DMM / VTCA Reclamation Award Nomination

# East Ridge Hollow Fill

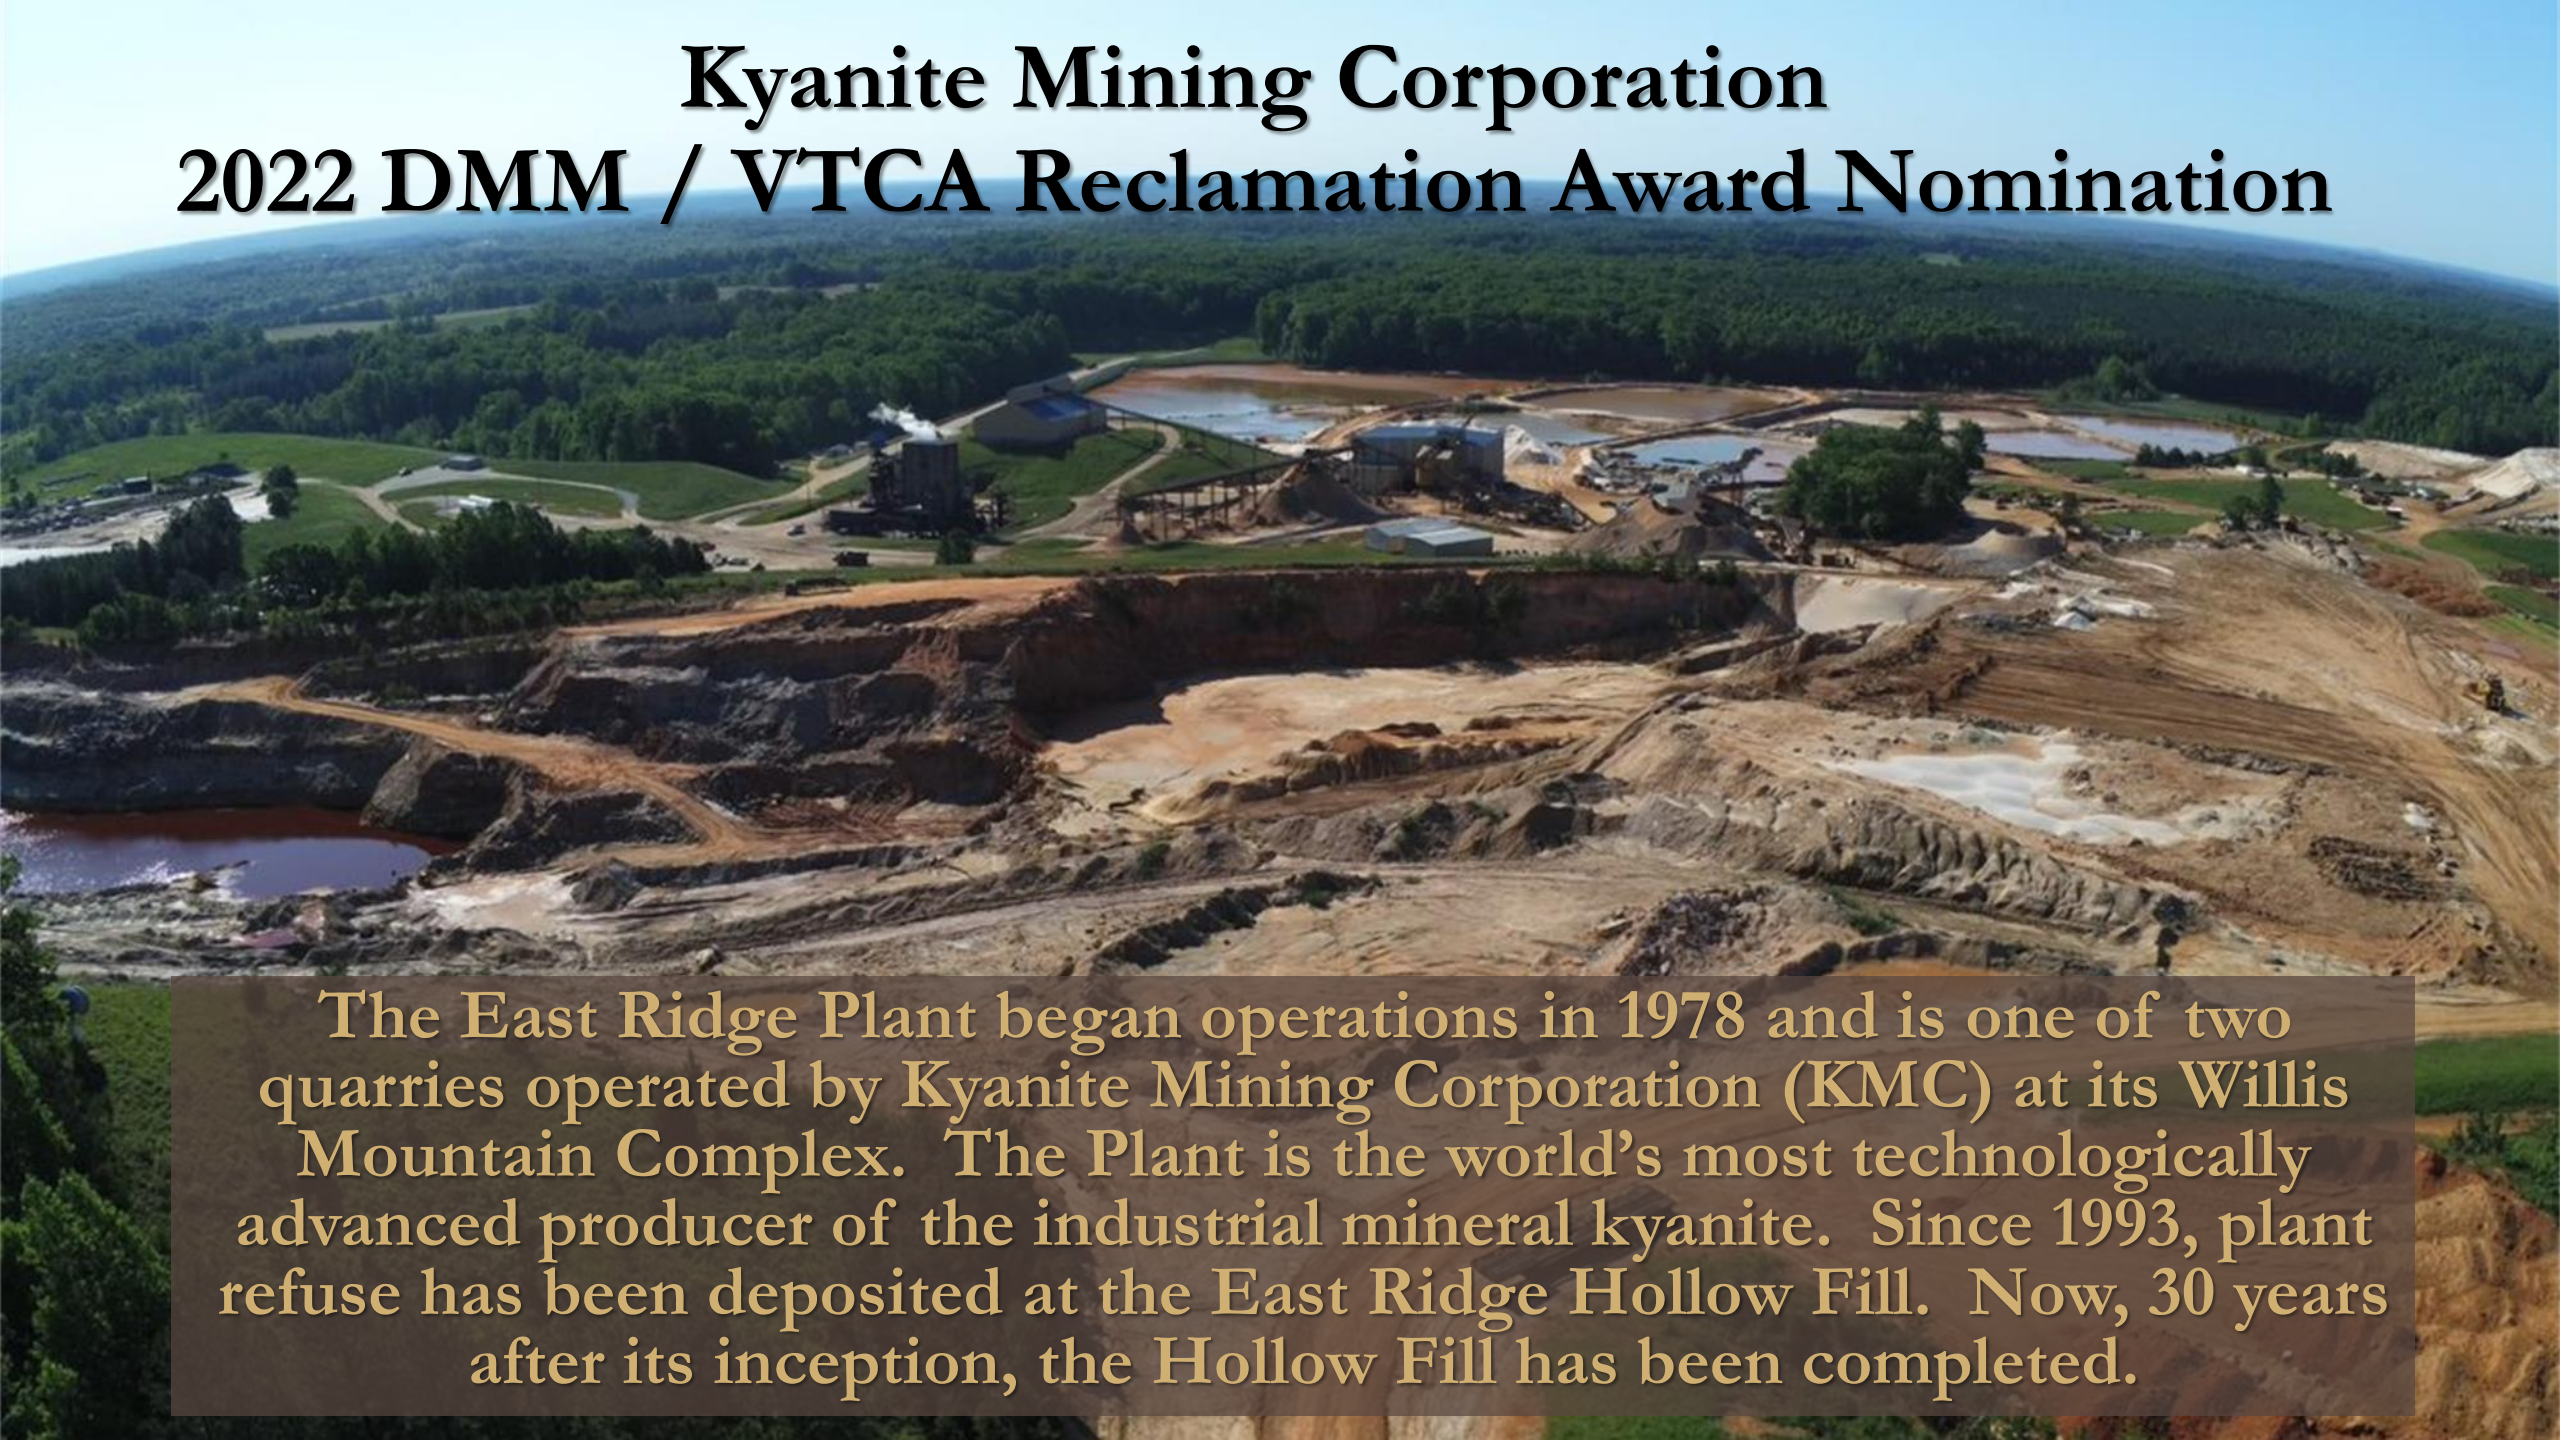
An aerial photograph showing a large-scale mining and reclamation project. In the foreground, a massive, terraced earthwork structure, the East Ridge Hollow Fill, is visible, showing various levels of construction and erosion control. Behind this, the East Ridge Plant is situated, featuring several large industrial buildings, a tall smokestack emitting a plume of white smoke, and several large, circular settling ponds filled with a reddish-brown liquid. The entire facility is surrounded by lush green forested hills under a clear blue sky.

The East Ridge Plant began operations in 1978 and is one of two quarries operated by Kyanite Mining Corporation (KMC) at its Willis Mountain Complex. The Plant is the world's most technologically advanced producer of the industrial mineral kyanite. Since 1993, plant refuse has been deposited at the East Ridge Hollow Fill. Now, 30 years after its inception, the Hollow Fill has been completed.

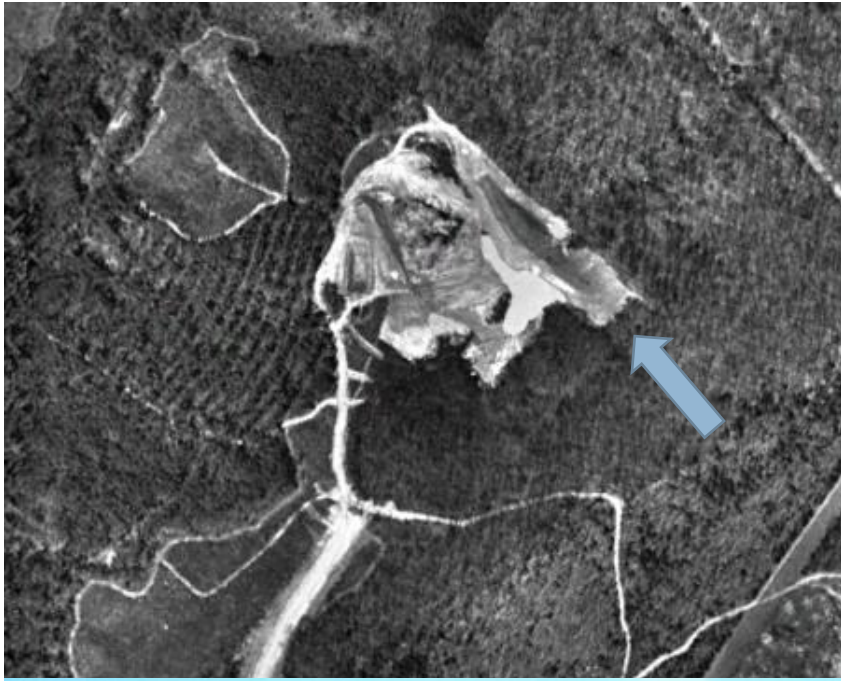
In this aerial photo from the mid-1990's, the Hollow Fill can be seen a few years into its lifespan. The Hollow Fill was developed as a 15-acre tailings disposal area north of the East Ridge Plant.

The fill was started behind a sediment control dam. One of the first sediment control dams can be seen in the aerial photo impounding storm water behind the northeastern slope. ➡

Concurrent reclamation began in the mid-1990's, shortly after the structure was started. As each level of the waste disposal area was completed, another control dam was constructed. These dams evolved into drainage benches used to convey runoff, via riprap groin ditches, to sediment basins below the toe. The top of each sediment control dam became the drainage bench on the terraced slope shown here.

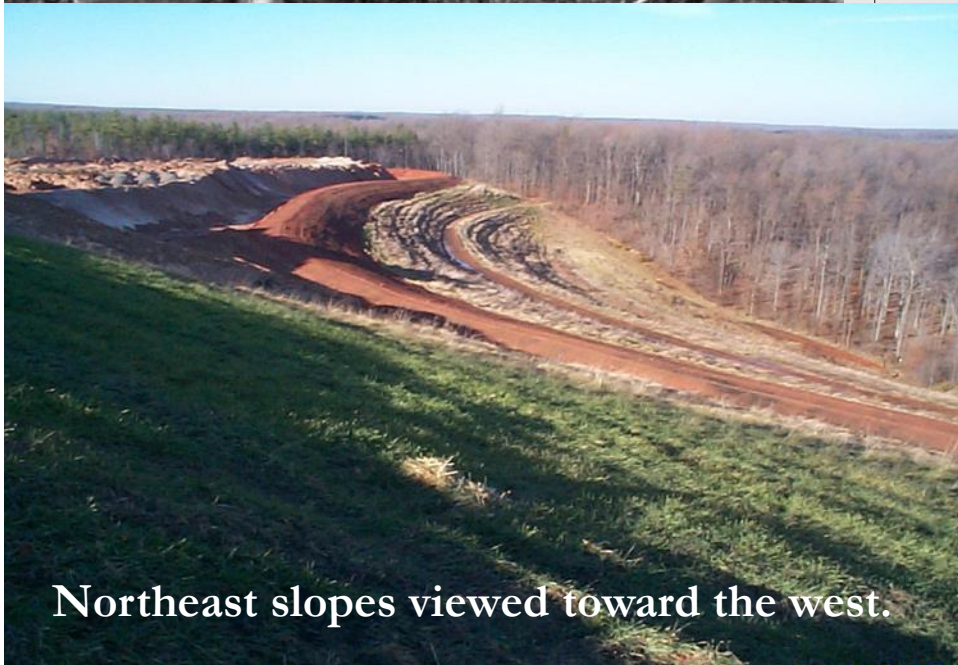
Northeast slopes viewed toward the west.

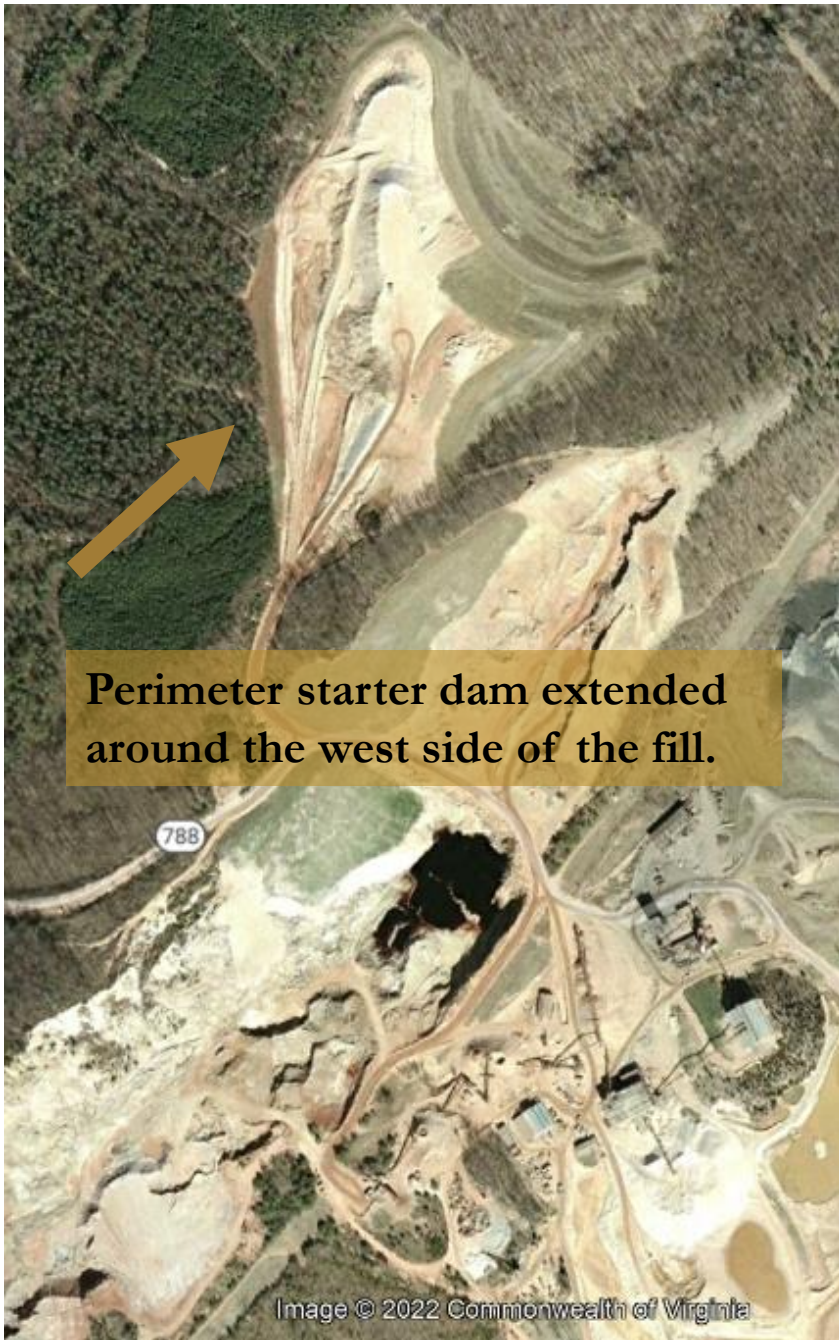
Sediment control dams, constructed downgradient of every phase of fill expansion, ensured that KMC captured runoff and prevented the loss of eroded material.

In the early 2000's, KMC extended the perimeter dam around the west side of the fill and continued to raise the height of the fill.

As the upper slopes reached capacity, they were graded down to the interior crest of the control dams, on maximum 3:1 grades.

The reclaimed outslopes evolved into the terraced slopes seen here on the northeastern face of the fill.

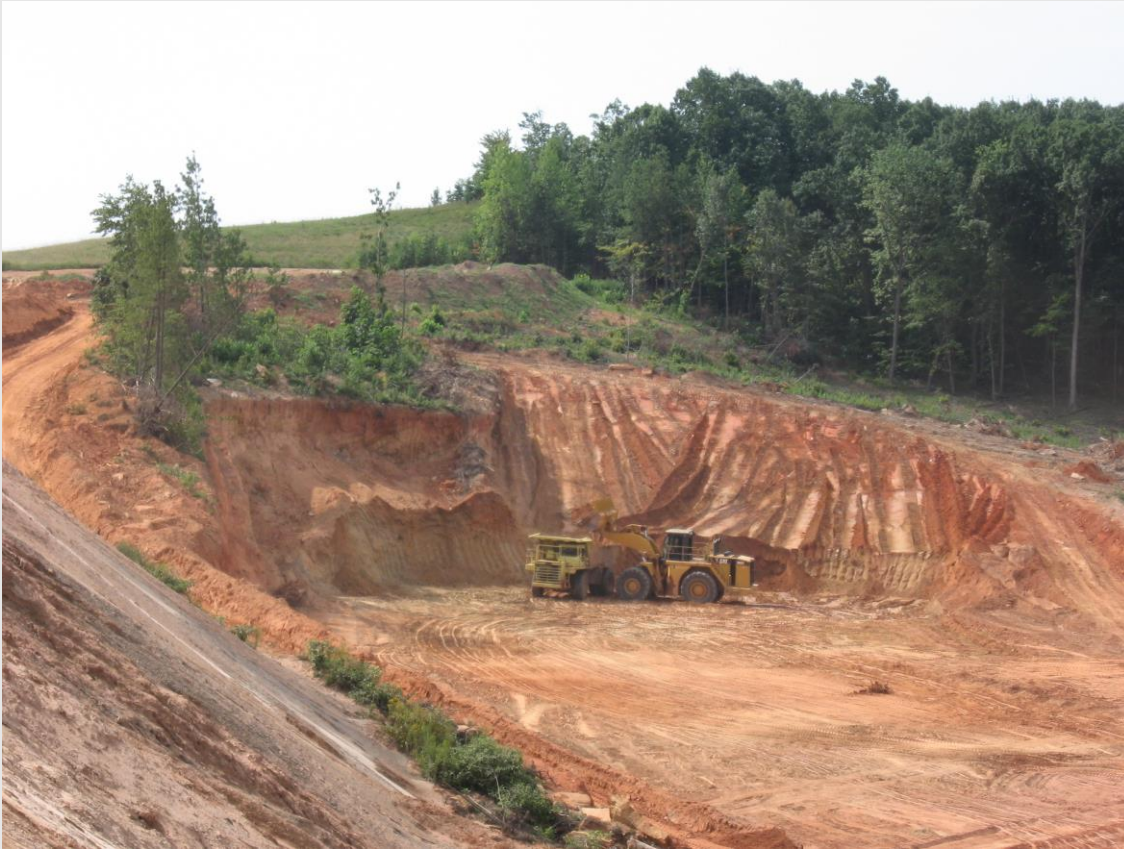
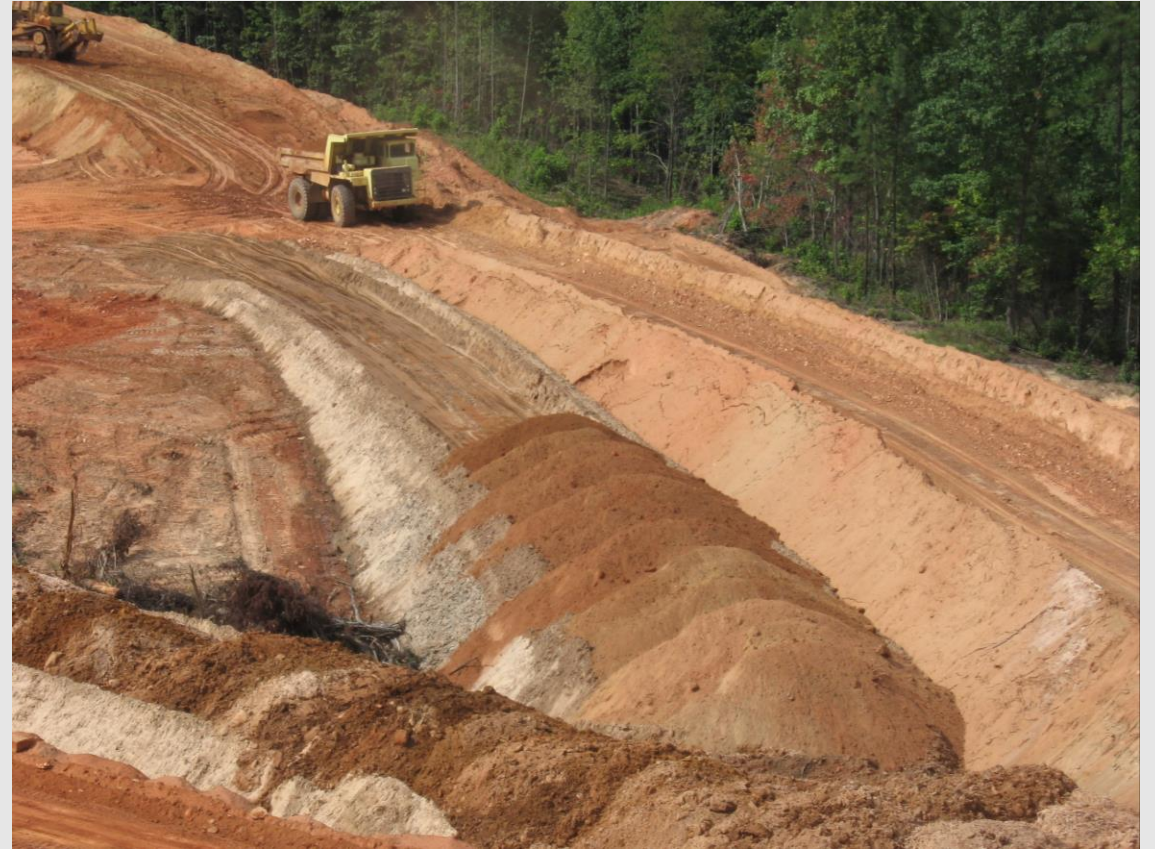
Fill placement began with construction of sediment control dams around the perimeter of the fill. The starter dams were constructed of select native soil that was spread and compacted in lifts on a clean and competent substrate. Keyways were excavated under the dams prior to the placement of material.

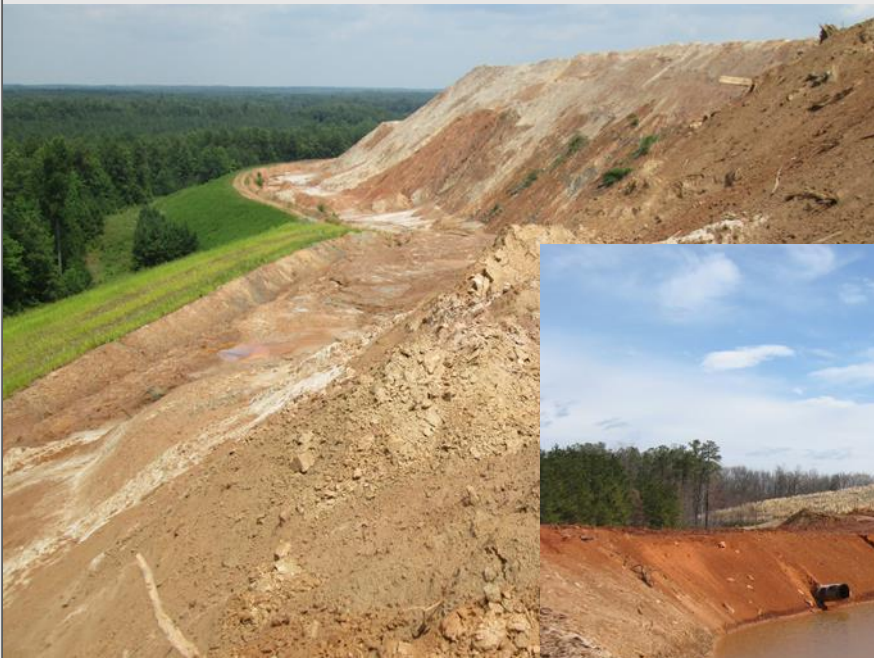
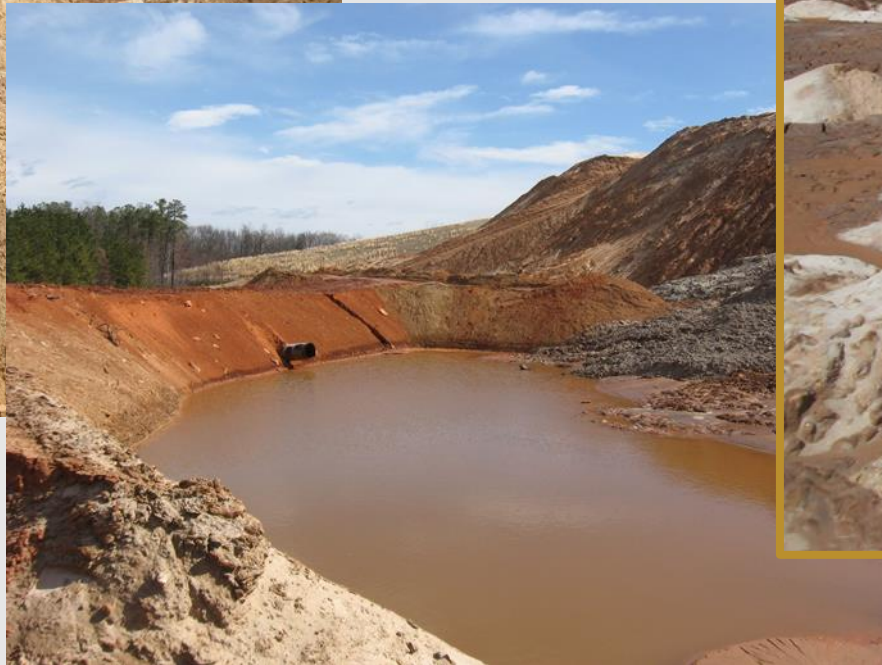
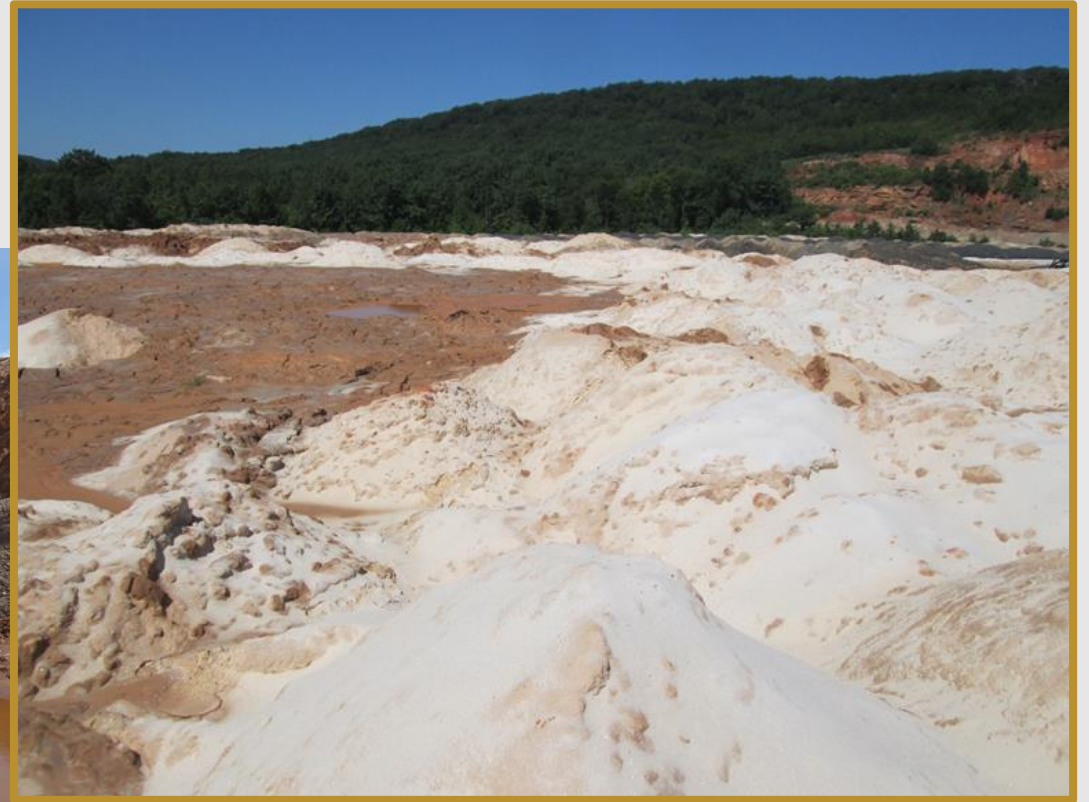
The starter dams provided perimeter drainage and sediment control, diverting runoff to perimeter sediment basins. Care was taken to place coarser, drier tails near the working face of the fill. Finer, wetter tails were placed further from the working face to allow more drying time before being incorporated into the rest of the fill.

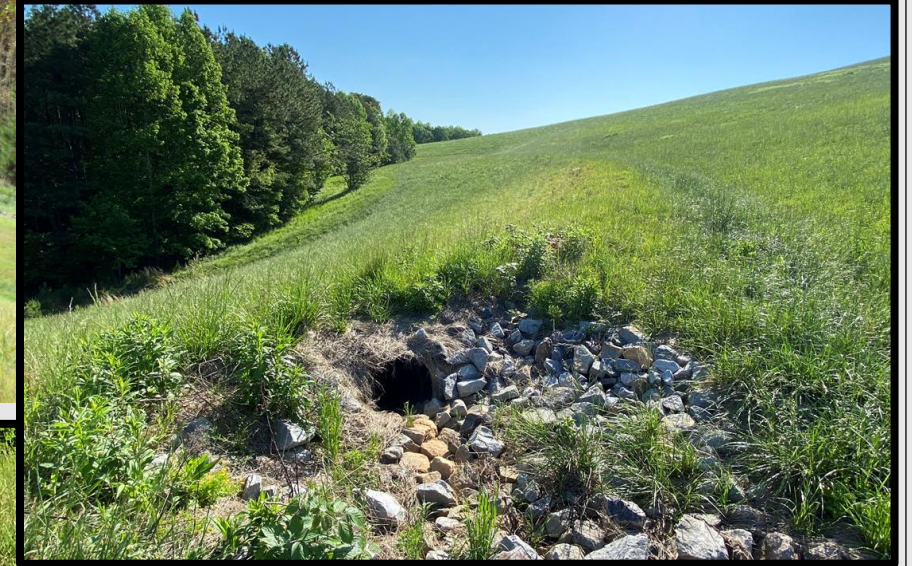
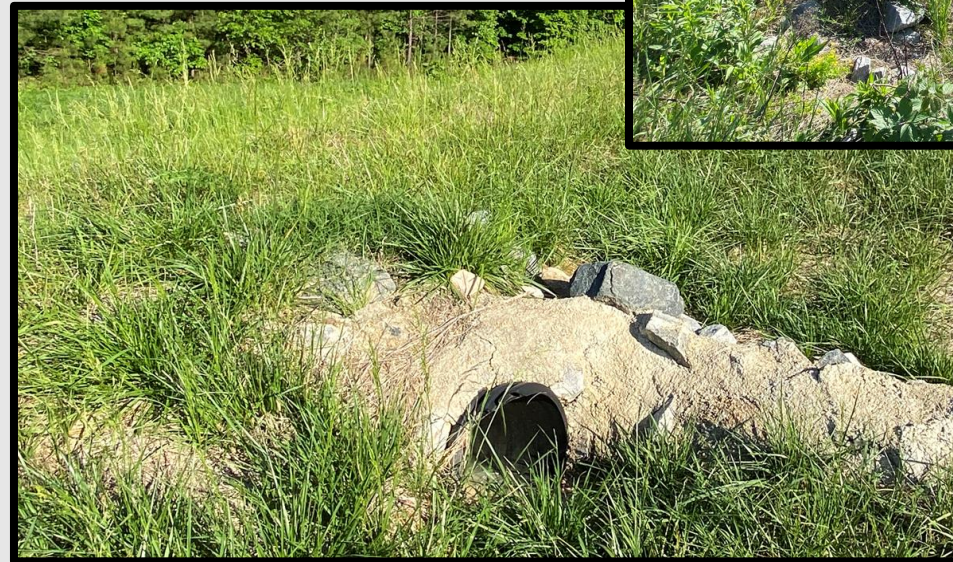
To shed water, KMC first tried open channel, rock-lined drains, but found them prone to erosion and difficult to navigate with maintenance equipment. The company then switched to pipe slope drains.

The surface area draining to each pipe determined the location and pipe size.

Whether armored by rip rap (top) or concrete (bottom), KMC prefers to bury their slope drains to facilitate long-term maintenance of the fill.

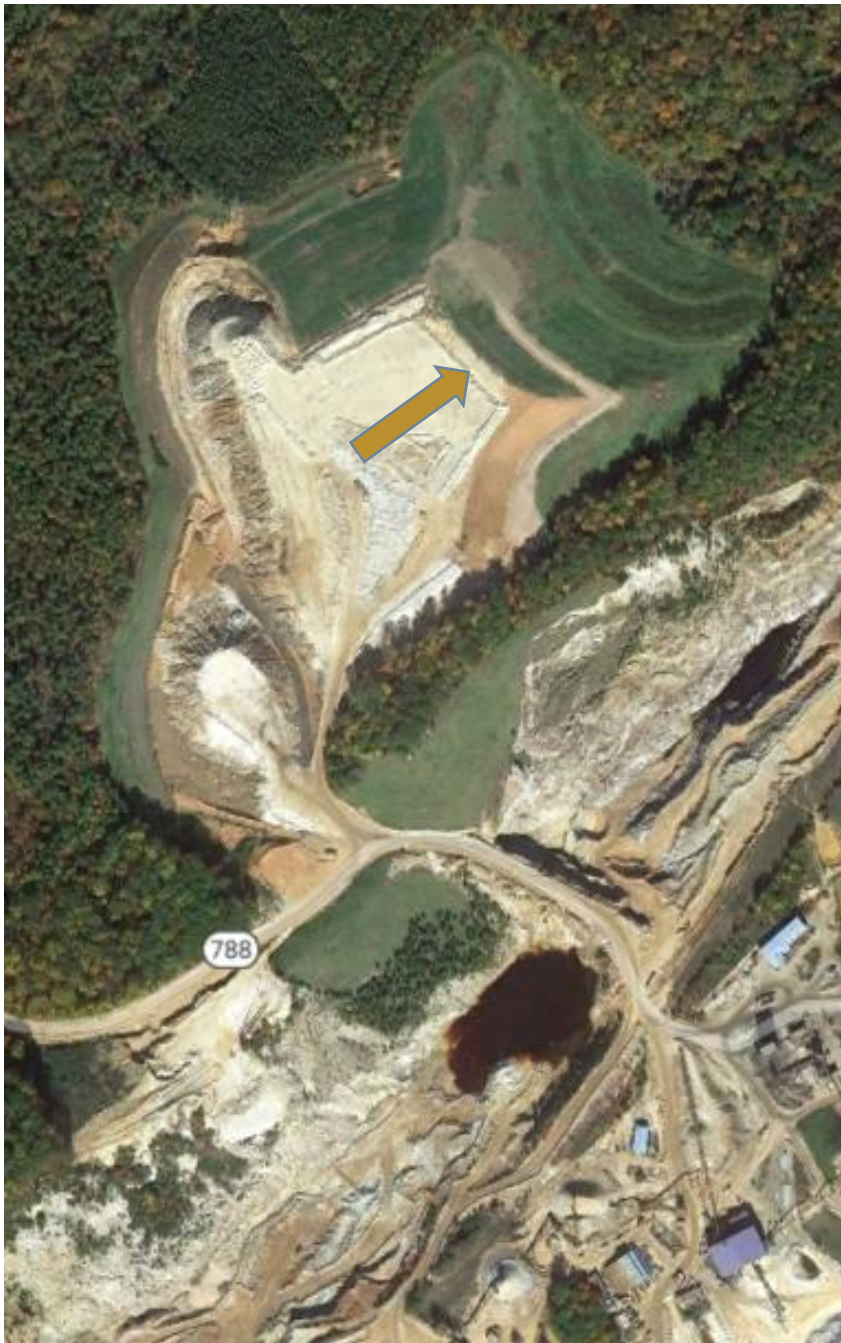
In 2012, KMC expanded the fill to the southwest behind another sediment control dam. By now, the fill had expanded to 55 acres.

In addition to annual fertilization, KMC amends the reclaimed areas with Class A wood ash, sourced from a local paper mill. As seen here, a healthy vegetative cover is the result.

In late 2011, KMC commissioned a geotechnical study, complete with cone penetrometer soundings, to ensure the foundation could support a 40-foot height increase.

The foundation proved solid. This photo shows the first of two, 20-foot height increases under construction behind the original northeastern slope.

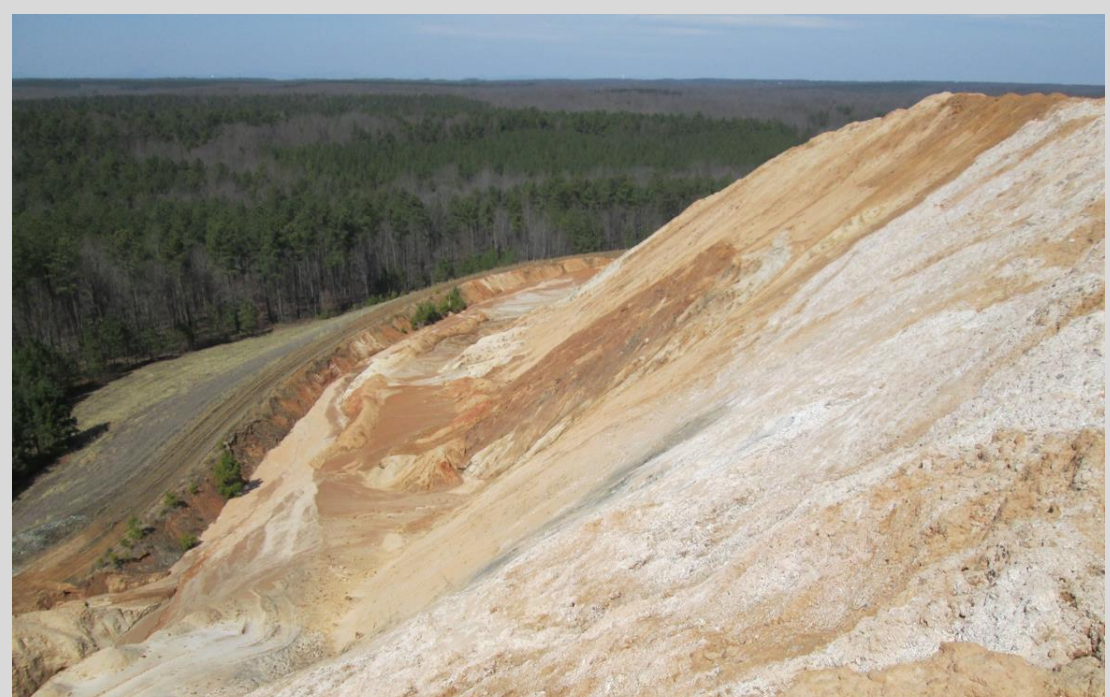
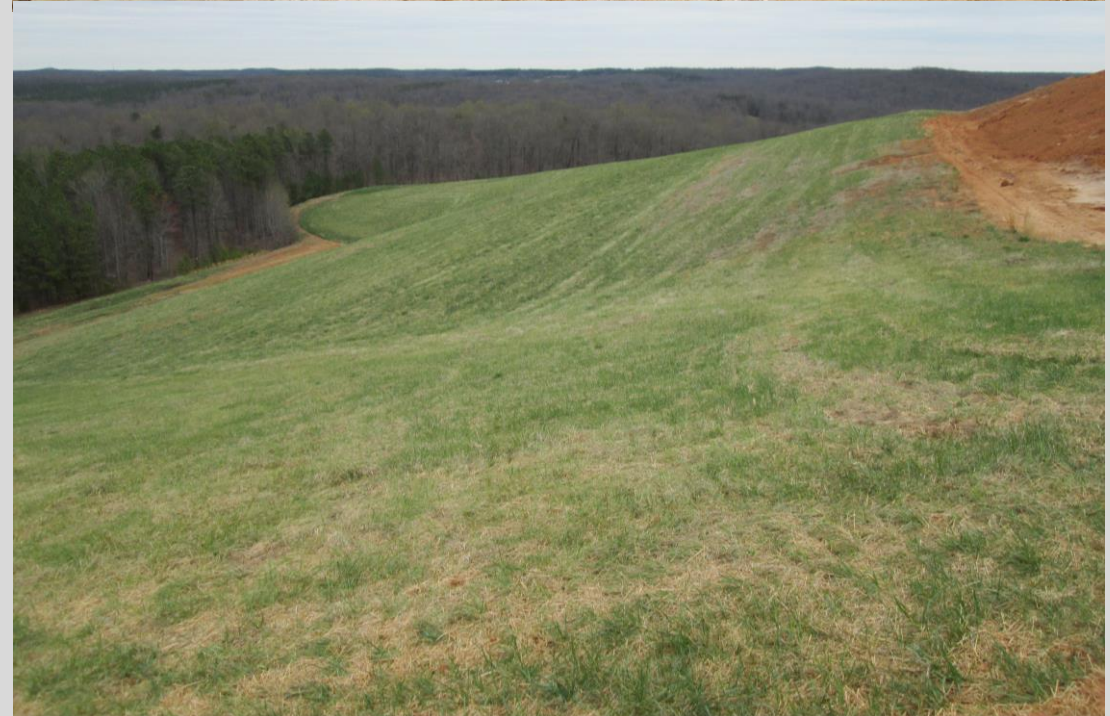
In 2011, KMC proposed the use of a long slope above the northwestern starter dam.

Through appropriate planning and careful implementation, an 80 foot tall long slope was completed without stability problems or excessive erosion.

As a result, another request was granted, in 2015, to extend the long slope along the entire western slope of the fill.

The long slopes aid in maintenance of the fill by increasing mower stability, reducing mower scalp on the underlying vegetation, aiding in annual lime application, and eliminating differential settling and water retention in drainage benches. Positive drainage also minimizes acid seeps.

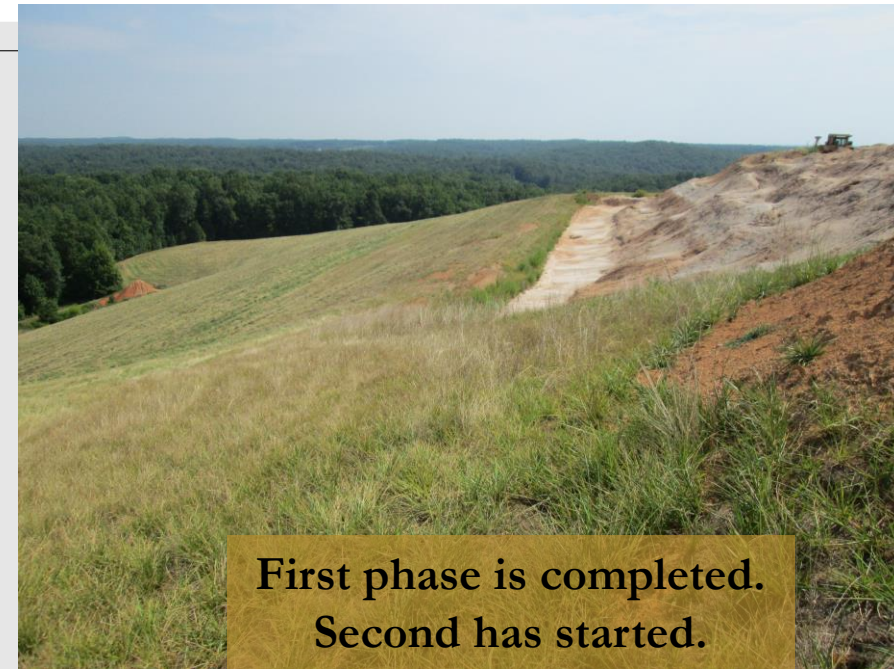
**First phase is completed.  
Second has started.**

To minimize erosion during final grading and topsoil placement, KMC constructed the long slopes in two levels, or phases. As soon as the first level was roughed in, slopes were placed on grade, covered with topsoil, and seeded. When the next level of the long slope was completed, it was tied into the lower level on the same grade.

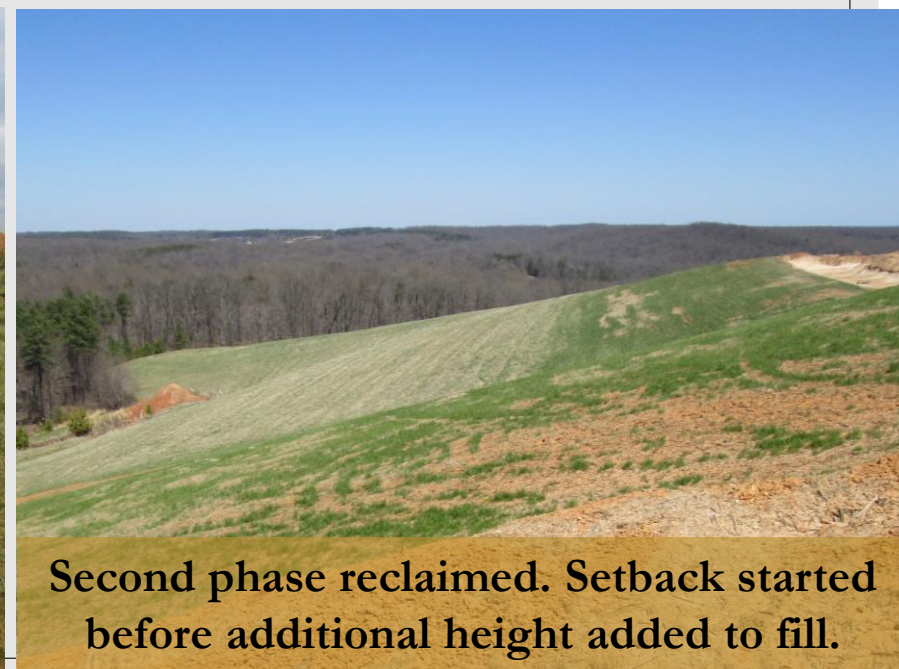
**Second phase reclaimed. Setback started  
before additional height added to fill.**

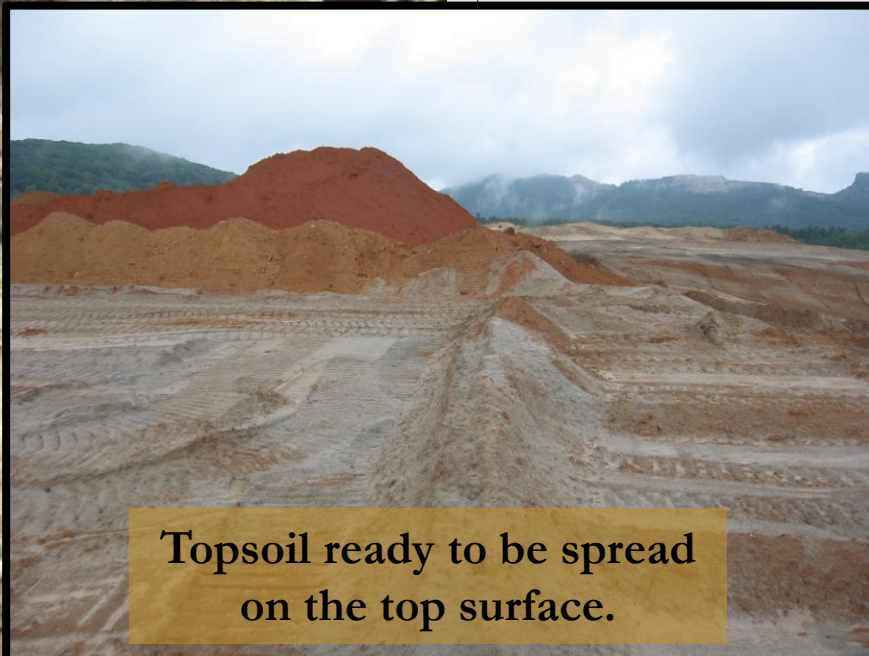
**Topsoil ready to be spread  
on the top surface.**

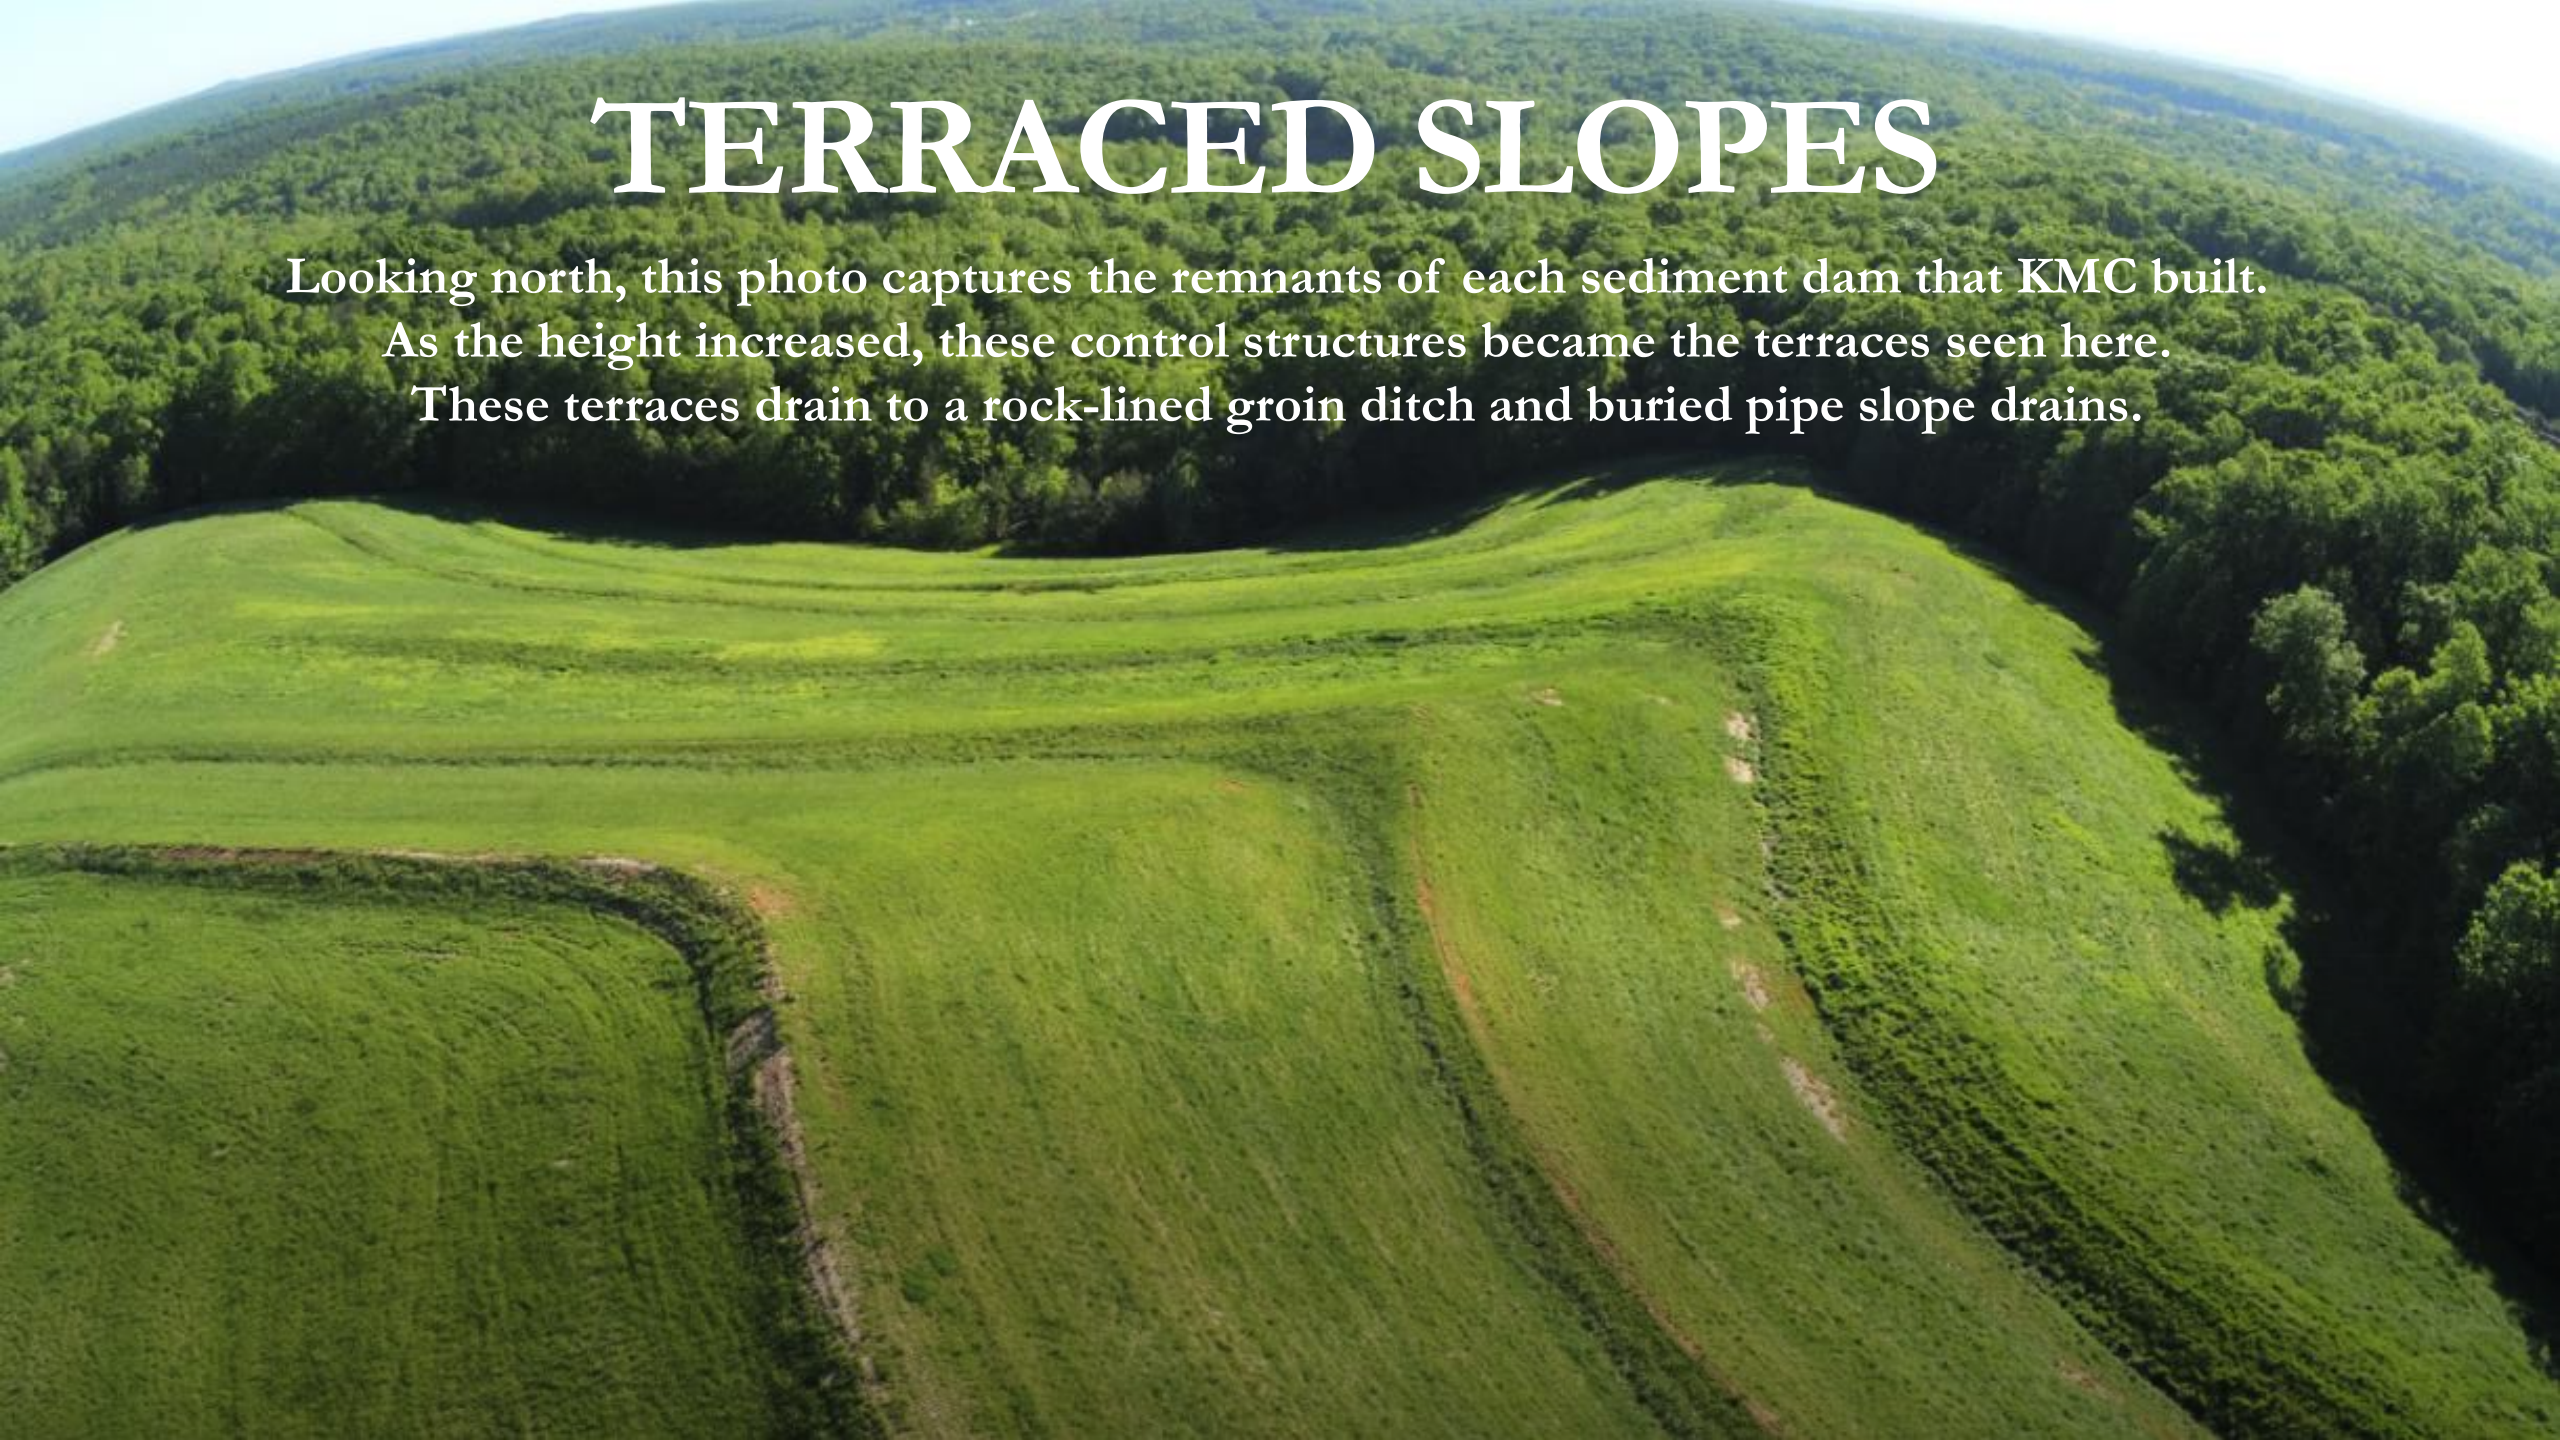
Looking north, this photo captures the remnants of each sediment dam that KMC built. As the height increased, these control structures became the terraces seen here. These terraces drain to a rock-lined groin ditch and buried pipe slope drains.
