# Kyanite Mining Corporation

## 2022 DMM / VTCA Reclamation Award Nomination

# East Ridge Hollow Fill

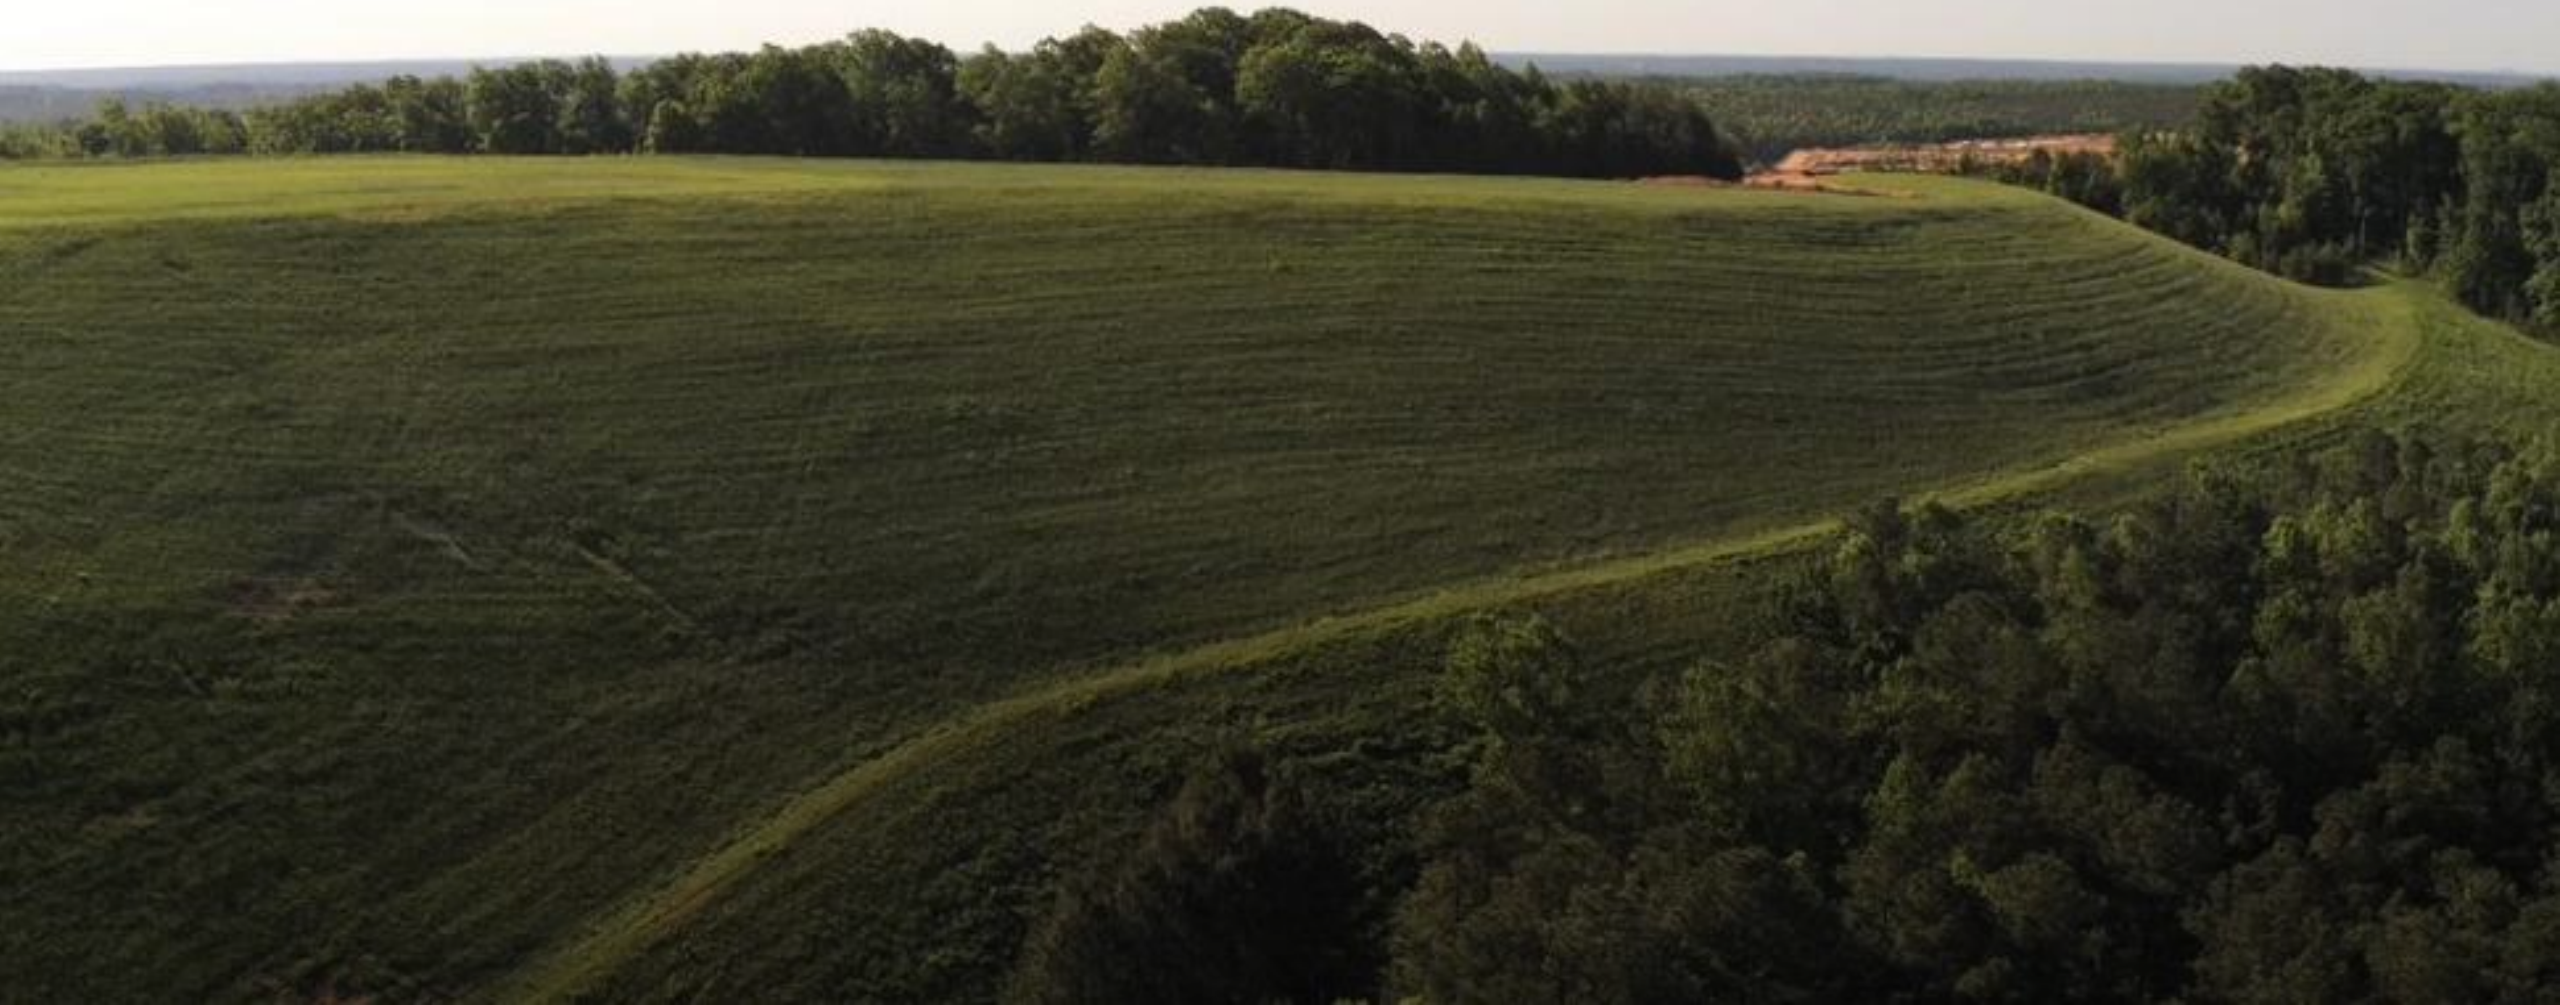
Looking south along the western slope,  
this long slope drains to the single terrace below.  
The terrace is drained with buried pipe slope drains.
